SUBJECT: Amendment No. 5 to RFP 11-17 Orient Road Re-Entry Building Roof Replacement

PROJECT: HCSO Re- Entry Center Roof Renovation
PROJECT NUMBER: 1715-00 / 04-07
ADDENDUM NO.: Five (05)
ADDENDUM DATE: 12/04/17

Company	Roof Assessment Specialists, Inc.	Customer	Wilder Architecture
Address	2605 72nd Avenue, #922 Ellenton, FL 34222	Site Address	1800 Orient Road Tampa, Florida
Thermographer	Ron Kough	Contact Person	John Thompson

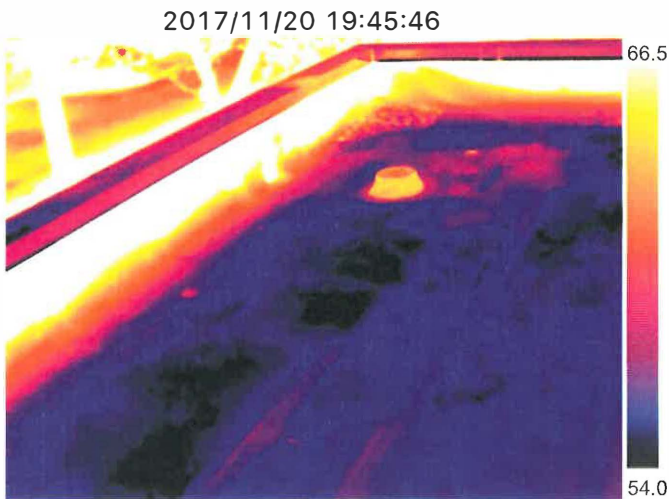
FLIR1676.JPG

Lower roof Southwest end Area #1 Core #2.
 Moisture between plies and damp ISO at
 bottom verified with impedance testing and
 core cut. Area under debris in corner could
 not be scanned.

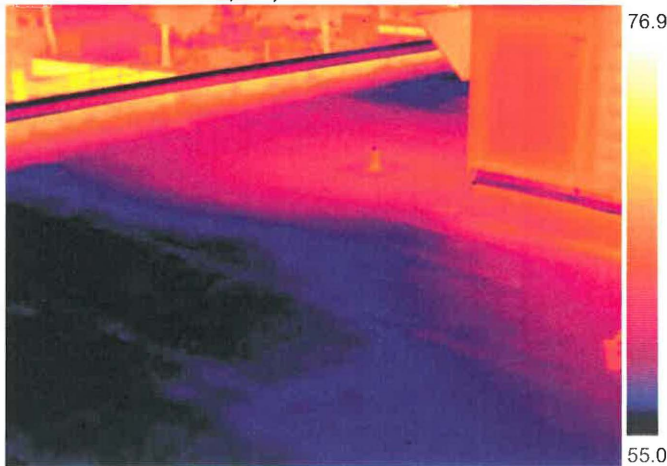
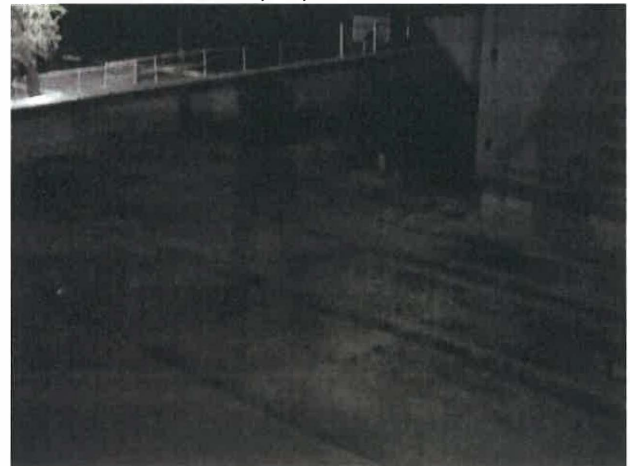
FLIR1678.JPG

Exhaust from mechanical unit on West side of lower roof. No elevated impedance was found.

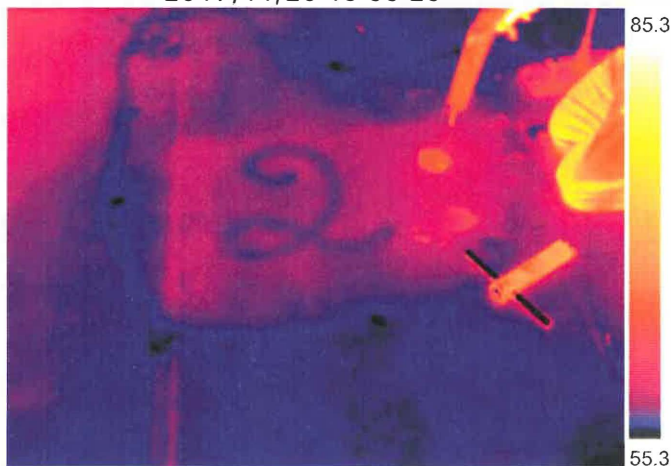
FLIR1684.JPG

Lower roof Area #2 Core #3 verified that the perlite contained moisture but the ISO was dry.

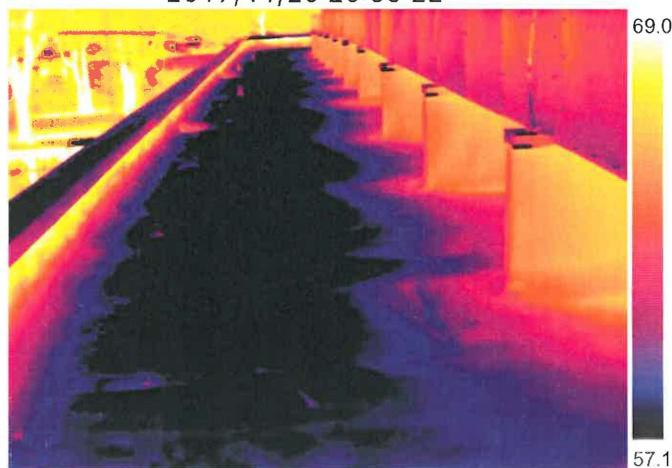
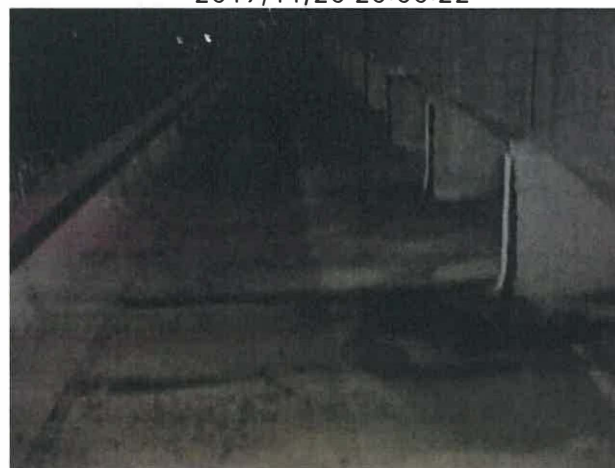
FLIR1691.JPG

Overview on the West side of the lower roof duct work with debris. No positive anomalies were found.

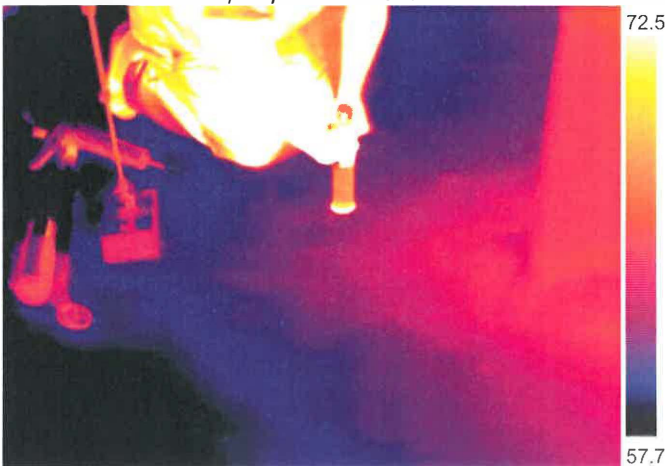
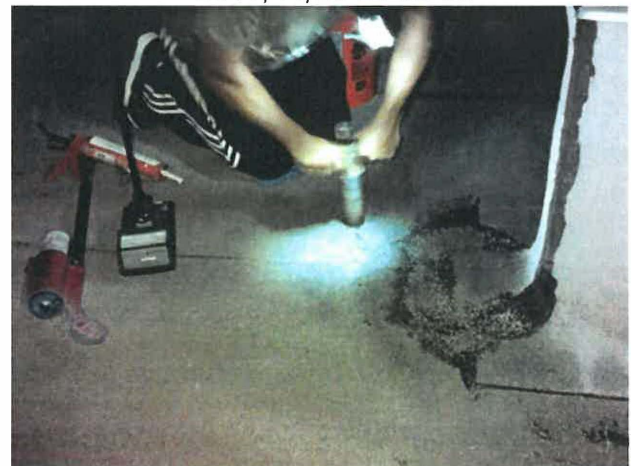
FLIR1696.JPG

Faint anomaly was checked and did not indicate any elevated impedance. Core cut #4 noted dry perlite and ISO. See CAD for location.

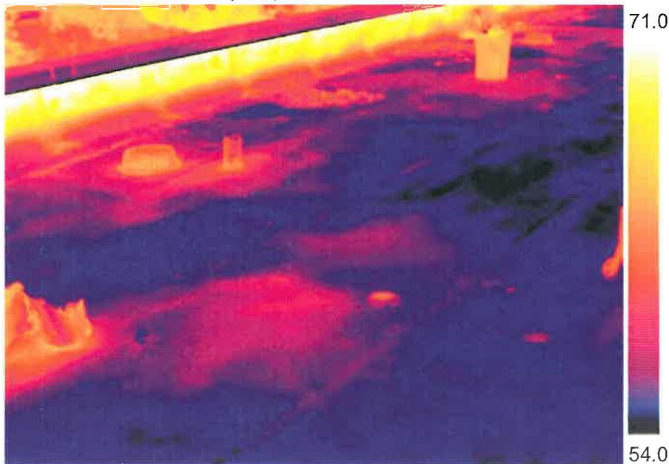
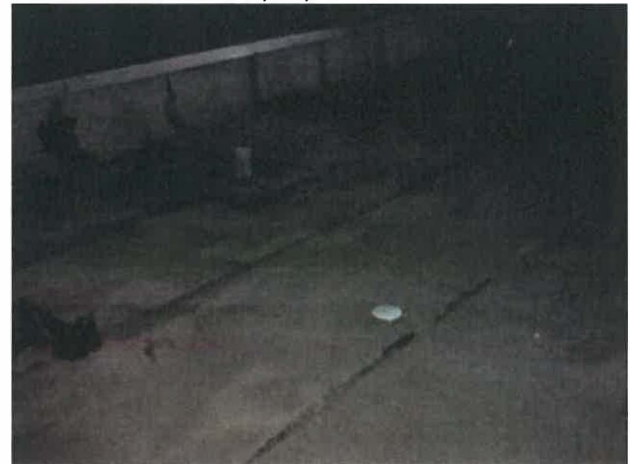
FLIR1700.JPG

The North end of the lower roof with debris and anomalies. Identified as area #3 with core cut #5 & #6. #5 was wet between the plies and #6 contained moisture between the plies and the perlite was wet.

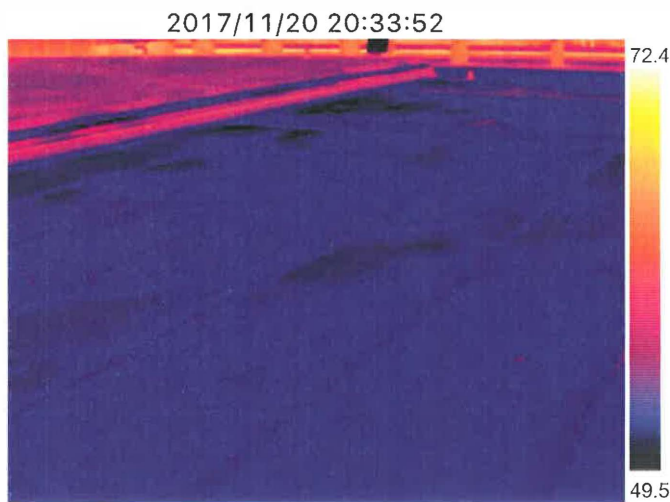
Heavy asphalt and repair indicate faint anomalies. No elevated impedance was noted.

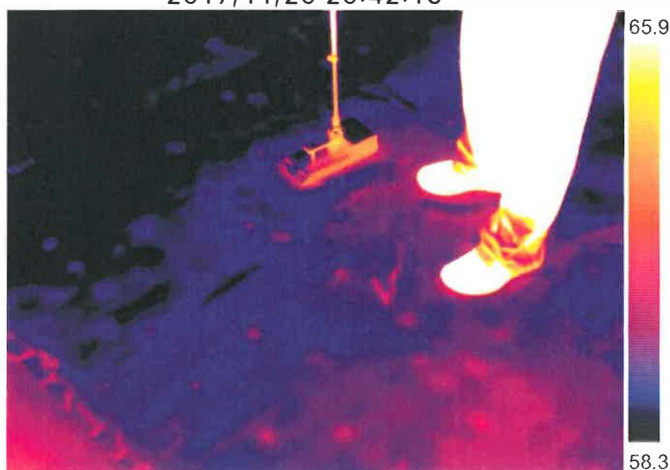
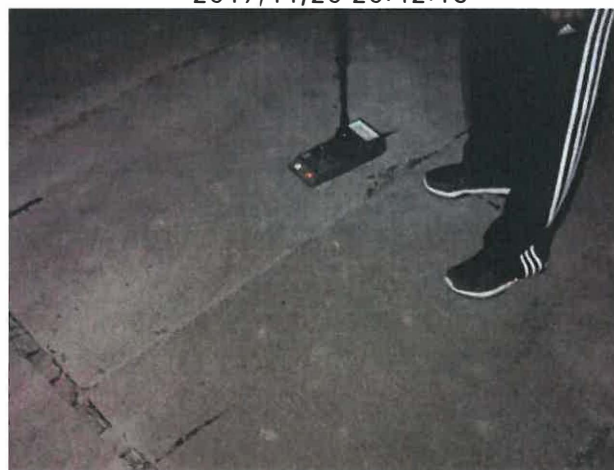
FLIR1713.JPG

Area on the East side of the upper roof with reflection from wall. No elevated impedance was noted. Core #7 noted dry.

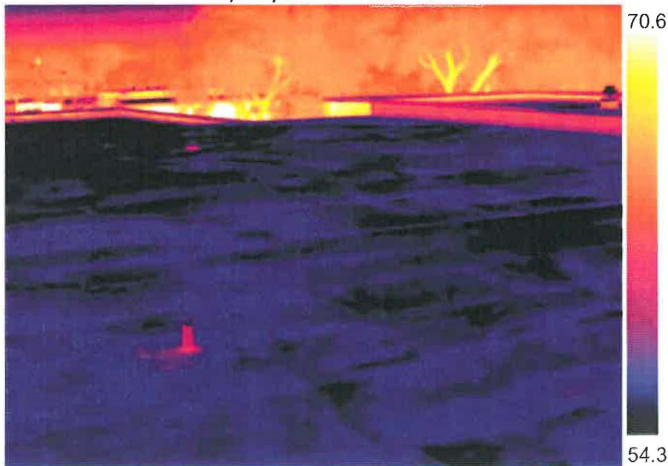
FLIR1721.JPG

Facing North with no positive anomalies found.

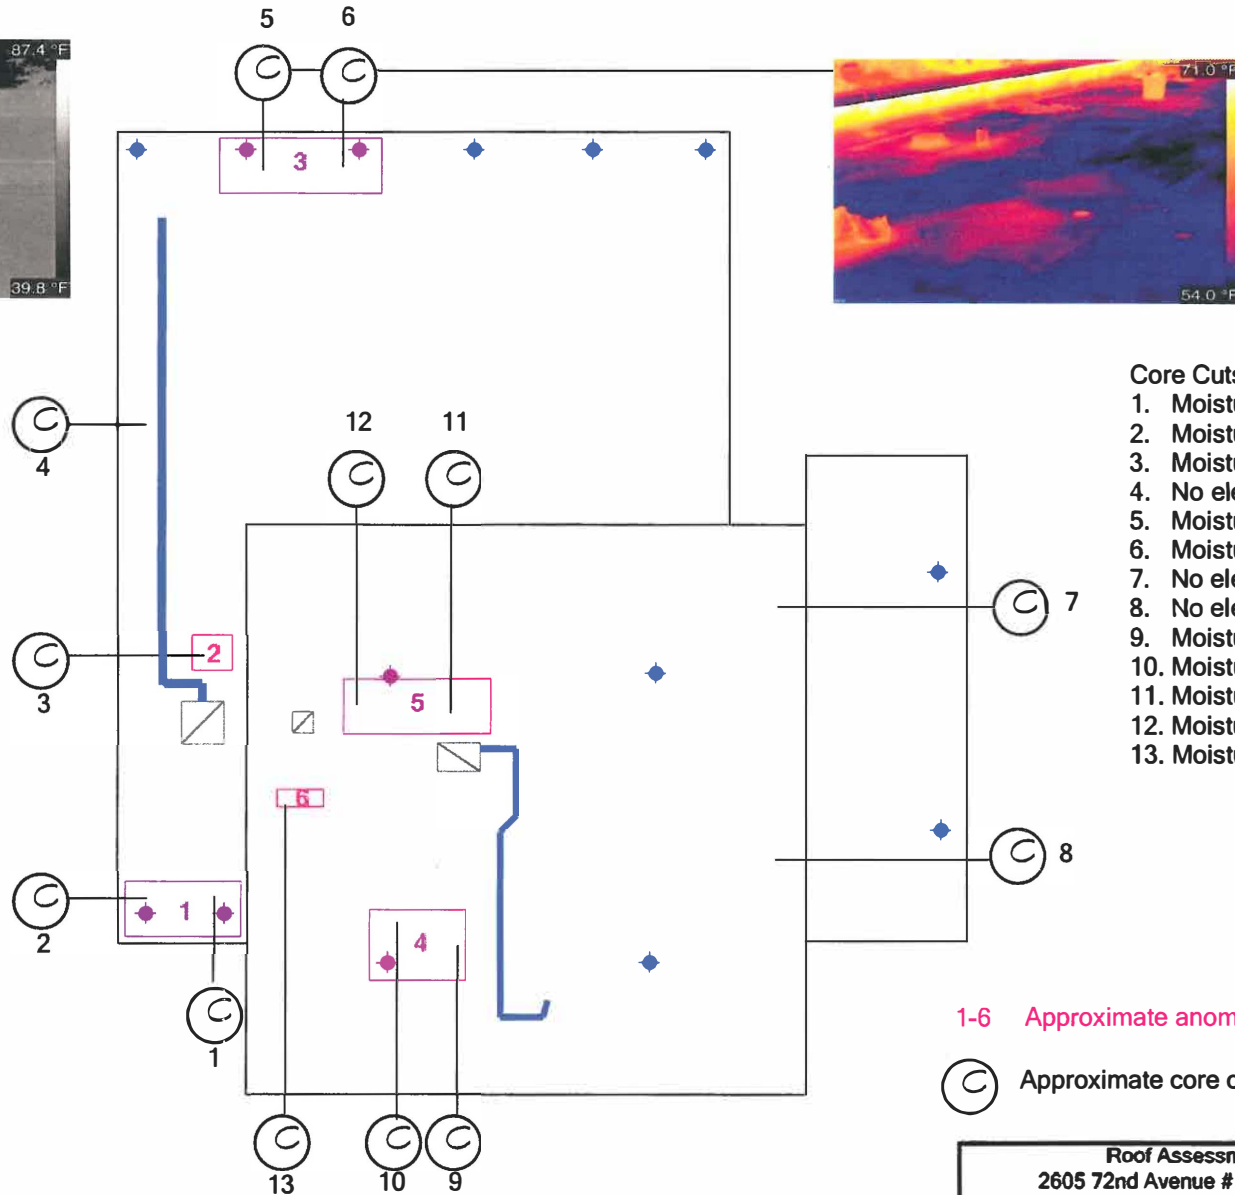
Core Cuts

1. Moisture in perlite & ISO.
2. Moisture between BUR plies.
3. Moisture in perlite-ISO dry.
4. No elevated impedance-dry.
5. Moisture between BUR plies.
6. Moisture between BUR plies.
7. No elevated impedance-dry.
8. No elevated impedance-dry.
9. Moisture between BUR plies.
10. Moisture on bottom of base ply.
11. Moisture between BUR plies.
12. Moisture between BUR plies.
13. Moisture between BUR plies.
