SUBJECT: Amendment No. 5 to RFP 11-17 Orient Road Re-Entry Building Roof Replacement

PROJECT: HCSO Re- Entry Center Roof Renovation
PROJECT NUMBER: 1715-00 / 04-07
ADDENDUM NO.: Five (05)
ADDENDUM DATE: 12/04/17

Company	Roof Assessment Specialists, Inc.	Customer	Wilder Architecture
Address	2605 72nd Avenue, #922 Ellenton, FL 34222	Site Address	1800 Orient Road Tampa, Florida
Thermographer	Ron Kough	Contact Person	John Thompson

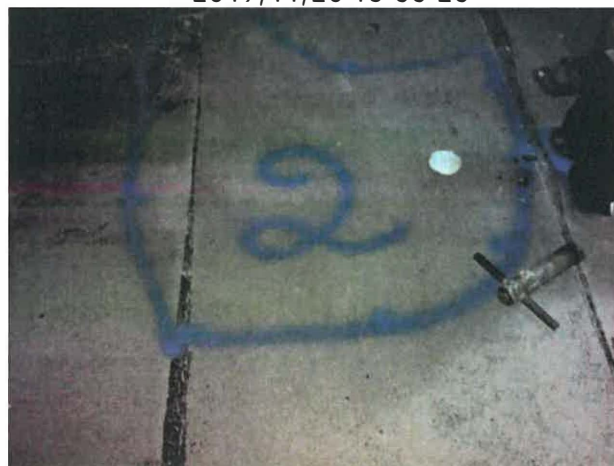
FLIR1684.JPG

Lower roof Area #2 Core #3 verified that the perlite contained moisture but the ISO was dry.

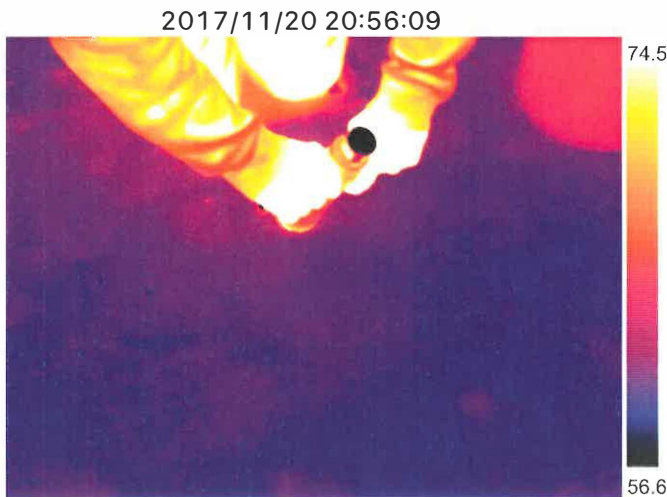
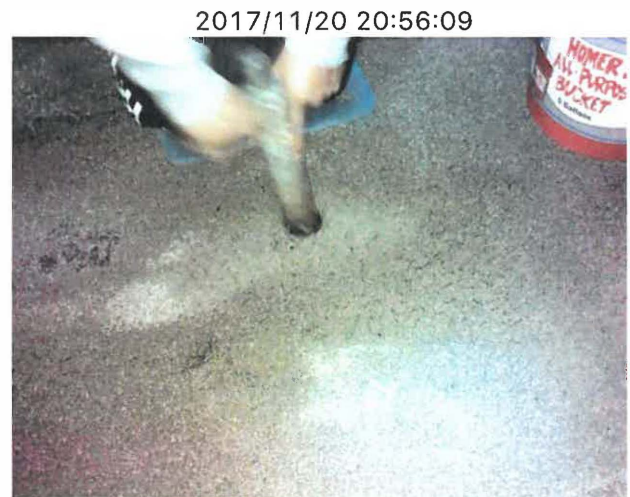
Core #9 of a faint anomaly on the West side of the duct work on the upper roof indicated moisture between the roofing plies.

1. Moisture in perlite & ISO.
2. Moisture between BUR plies.
3. Moisture in perlite-ISO dry.
4. No elevated impedance-dry.
5. Moisture between BUR plies.
6. Moisture between BUR plies.
7. No elevated impedance-dry.
8. No elevated impedance-dry.
9. Moisture between BUR plies.
10. Moisture on bottom of base ply.
11. Moisture between BUR plies.
12. Moisture between BUR plies.
13. Moisture between BUR plies.

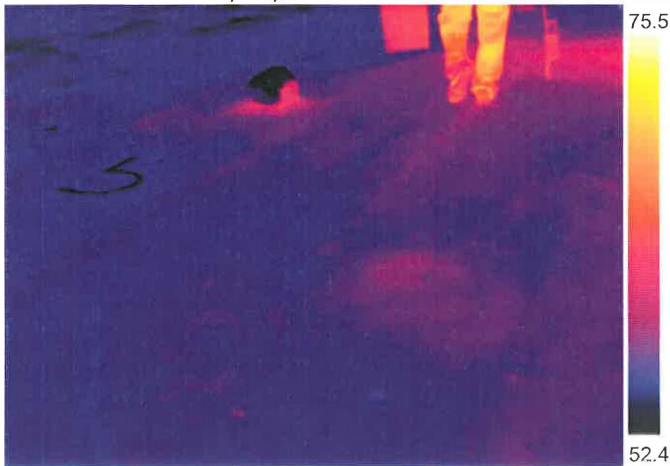
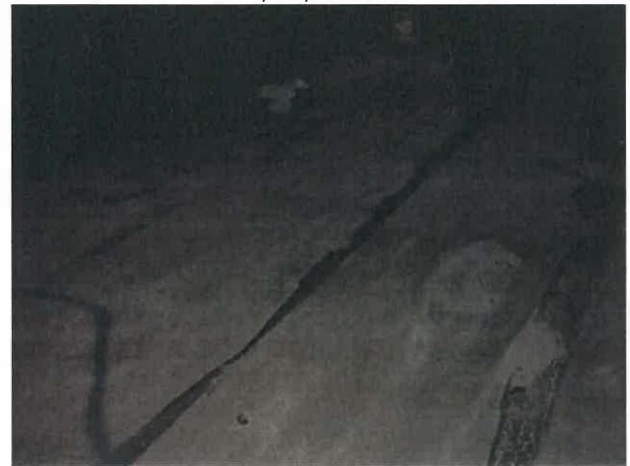
FLIR1730.JPG

Area #5 with Core #11 and #12 noting moisture between the roofing plies. See CAD for location.

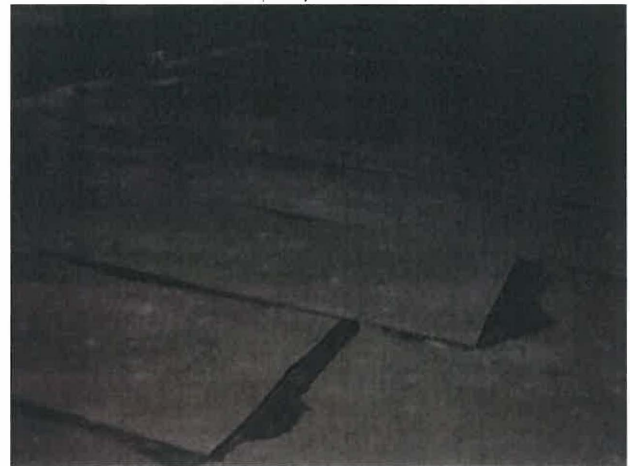
FLIR1733.JPG

Facing North with no positive anomalies found.

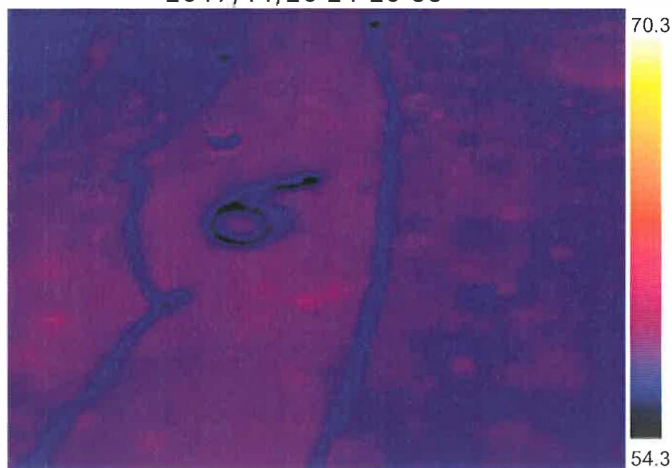
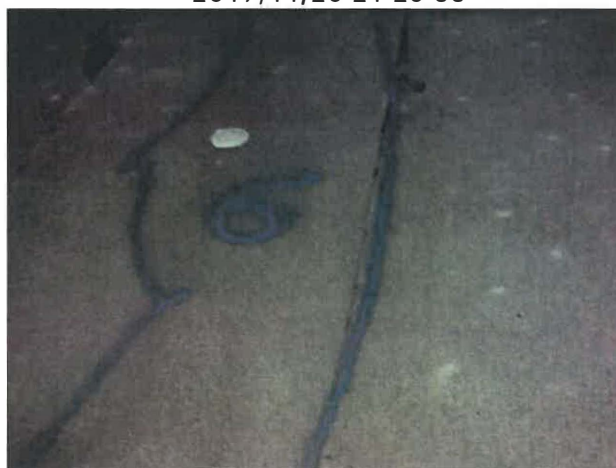
FLIR1738.JPG

Area #6 with Core #13 noted positive anomaly with moisture found between the roofing plies.
